## Data sheet

## Spare parts and accessories

Expansion valves TEA, TEAT, TEVA and TEAQ, size 20 and 85

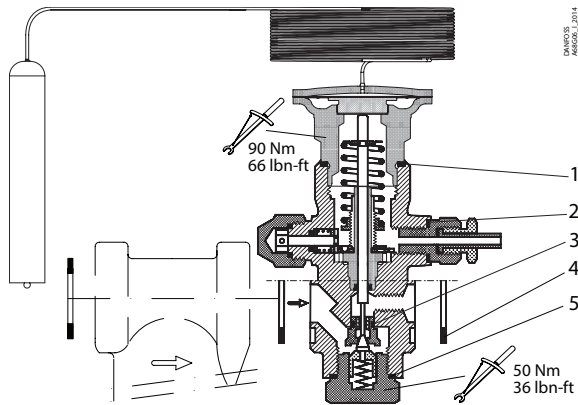
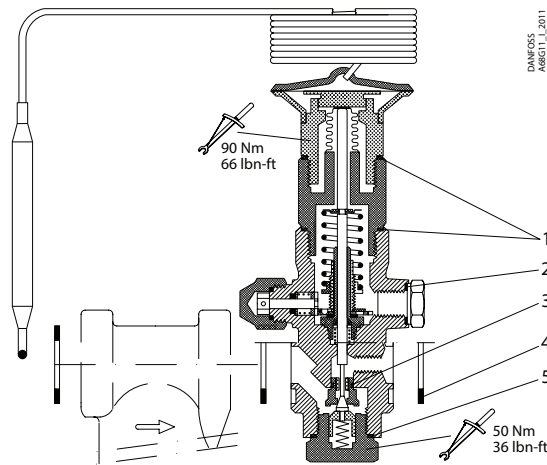
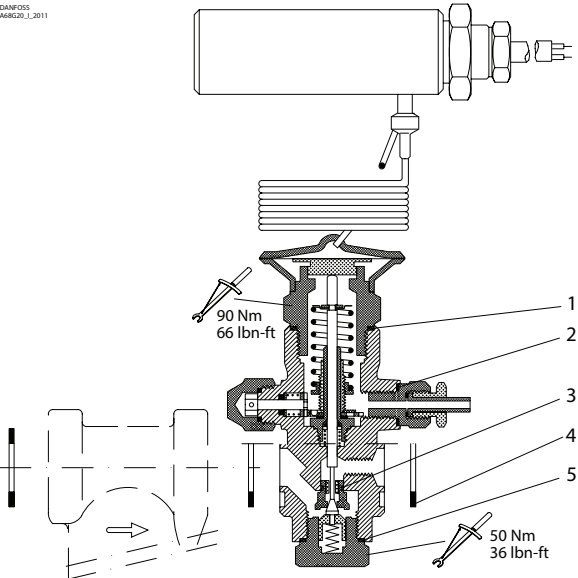
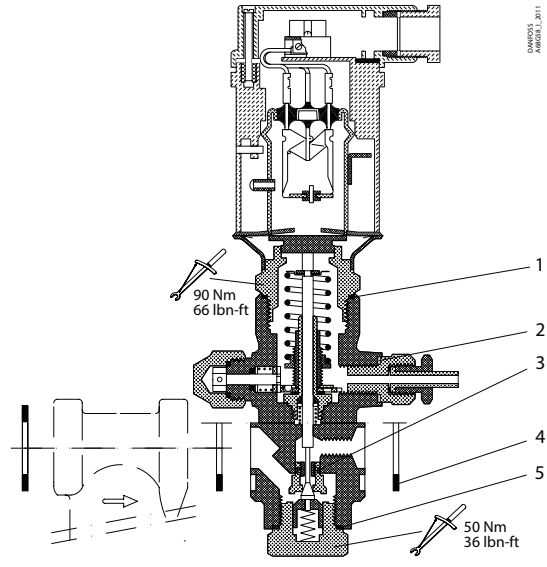
# Inspection kit | Code number 068G0064 TEA, TEAT, TEVA and TEAQ, Size 20 and 85

| <p><b>1</b></p> <p> = Alu.</p> <p></p> <p>Total no. = 2</p> | <p><b>2</b></p> <p> = Alu.</p> <p></p> <p>Total no. = 1</p> | <p><b>3 (size 20)</b></p> <p></p> <p></p> <p>Total no. = 1</p> | <p><b>3 (size 85)</b></p> <p></p> <p></p> <p>Total no. = 1</p> |
| <p><b>4 (size 20)</b></p> <p> = Fibre</p> <p></p> <p>Total no. = 3</p> | <p><b>4 (size 85)</b></p> <p> = Fibre</p> <p></p> <p>Total no. = 3</p> | <p><b>5</b></p> <p> = Alu.</p> <p></p> <p>Total no. = 1</p> | |

Contains all gaskets, O-rings and sealings belonging to 1 valve size.  
For detailed content, see specific pages mentioned above.

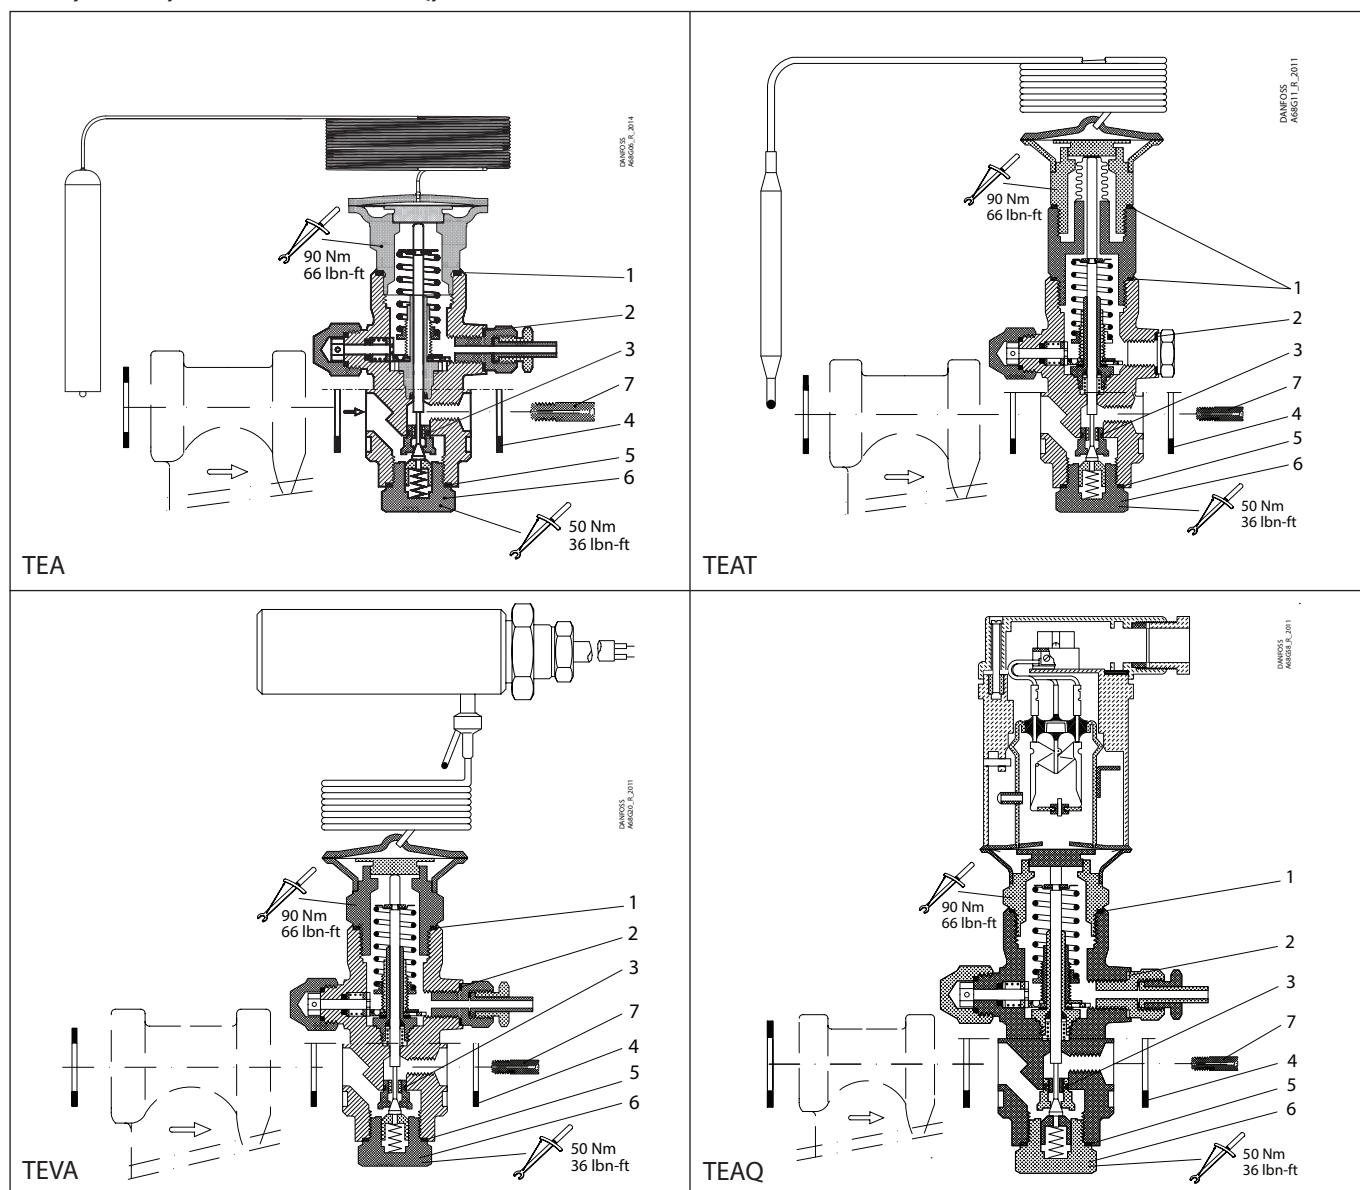
**Repair kit, orifice | Code numbers: 068G2050 / 068G2051 / 068G2052 / 068G2053 / 068G2054 / 068G2055 / 068G2056 / 068G2057 / 068G2058 / 068G2059**  
**TEA, TEAT, TEVA and TEAQ, Size 20 and 85**

| <b>1</b><br> | <b>2</b><br> | <b>3 (size 20)</b><br> | <b>3 (size 85)</b><br> | <b>4 (size 20)</b><br> |
| <b>4 (size 85)</b><br> | <b>5</b><br> | <b>6</b><br> | <b>7</b><br> | |
| Total no. = 2 | Total no. = 1 | Total no. = 1 | Total no. = 1 | Total no. = 3 |
| Total no. = 3 | Total no. = 1 | Total no. = 1 | Included in the repair kit<br><b>068G2050</b> only<br>Total no. = 1 | |

Repair kit orifice contains all gaskets, O-rings, sealings and one orifice belonging to one valve size.  
For detailed content, see specific pages mentioned above.

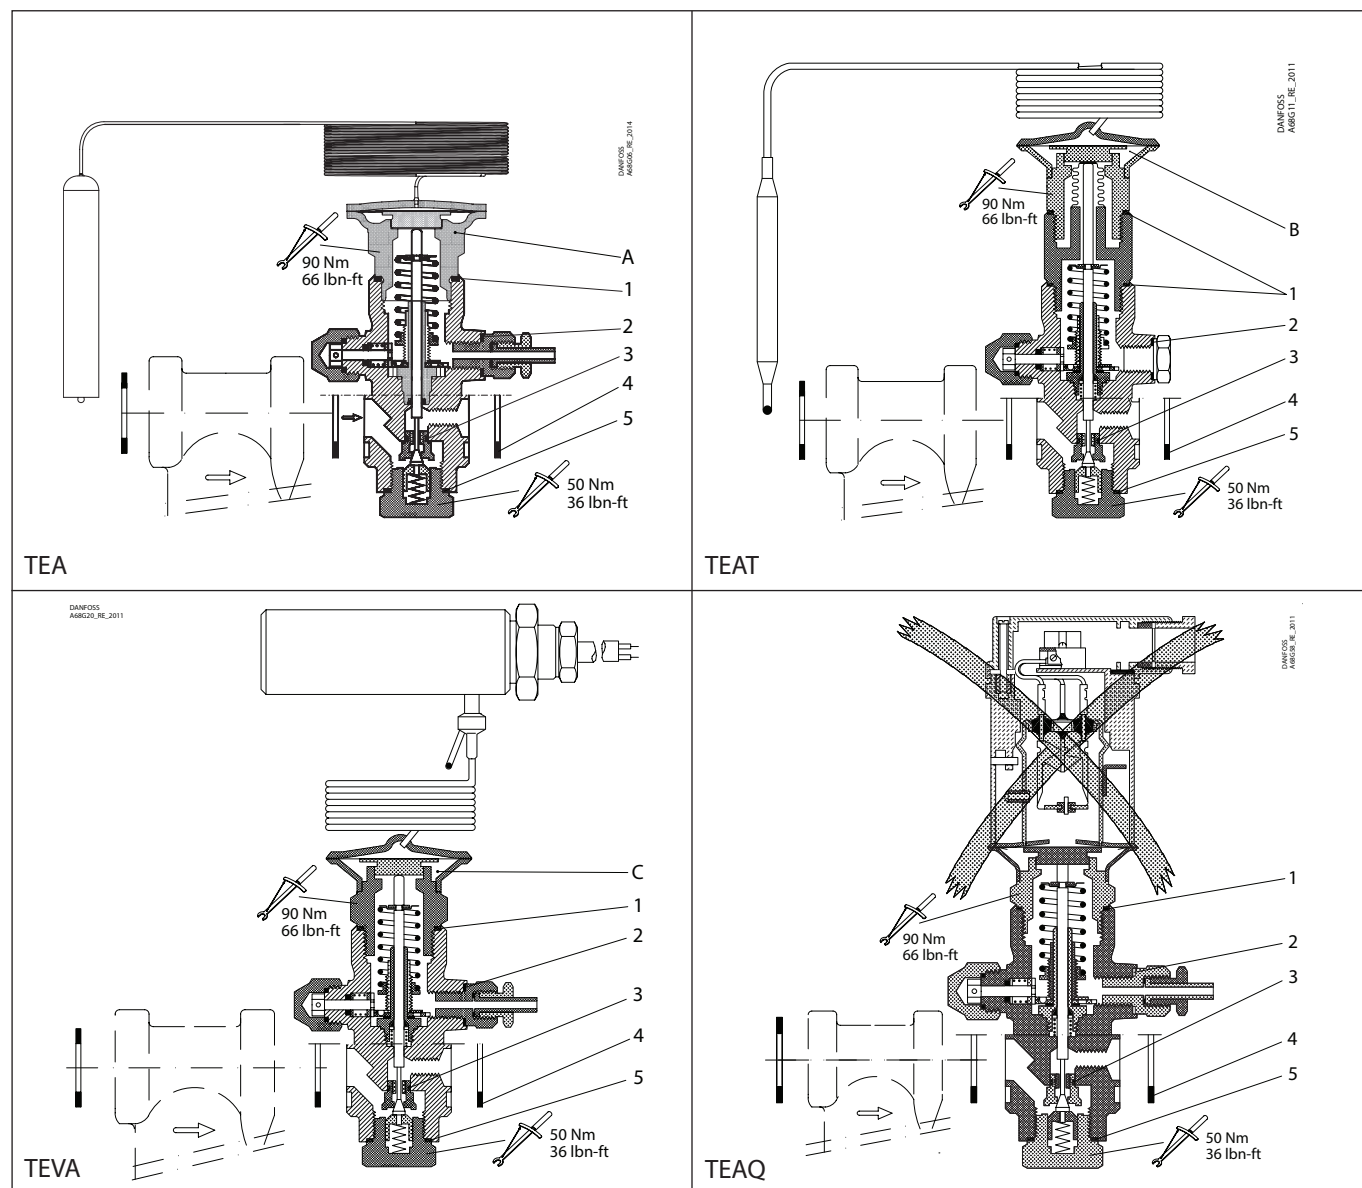
**Repair kit, element | Code numbers: 068G3250 / 068G3252 / 068G3260 / 068G3261 / 068G3262**  
**TEA, TEAT, TEVA and TEAQ, Size 20 and 85**

| <b>1</b><br><br>$\varnothing 36 \text{ mm}$<br>$\varnothing 1.42''$<br>Total no. = 2 | <b>2</b><br><br>$\varnothing 17.5 \text{ mm}$<br>$\varnothing 0.69''$<br>Total no. = 1 | <b>3 (size 20)</b><br><br>$\varnothing 8 \text{ mm}$<br>$\varnothing 0.32''$<br>Total no. = 1 | <b>3 (size 85)</b><br><br>$\varnothing 9 \text{ mm}$<br>$\varnothing 0.35''$<br>Total no. = 1 | <b>4 (size 20)</b><br><br>$\varnothing 32 \text{ mm}$<br>$\varnothing 1.26''$<br>Total no. = 3 | <b>4 (size 85)</b><br><br>$\varnothing 39 \text{ mm}$<br>$\varnothing 1.54''$<br>Total no. = 3 |
| <b>5</b><br><br>$\varnothing 26 \text{ mm}$<br>$\varnothing 1.02''$<br>Total no. = 1 | <b>6</b><br>1 of A or<br>1 of B or<br>1 of C | <b>Bulb strap</b><br><br>Total no. = 1 | | | |

Repair kit element contains all gaskets, O-rings, sealings and one element belonging to one valve size.  
For detailed content, see specific pages mentioned above.
